Manhole Inspection Summary

Manhole # S13OO1003MH

Insp Date: **11/29/06 8:59 AM**

Location Address: **2811 WOODLAND AVE**

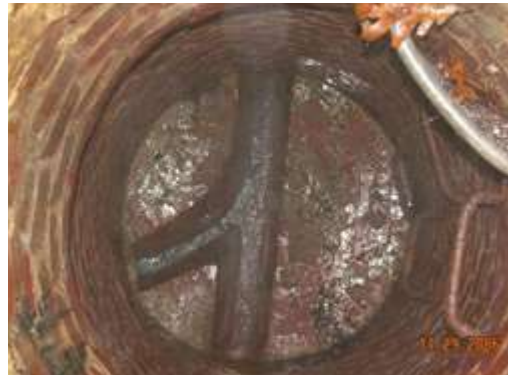
Top View

Count: **5** Missing: **0** ☒ **Corroded**

Corroded steps. Bench debris.

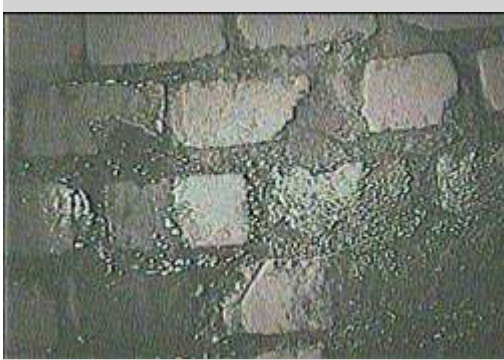
Defect

Infiltration: ☐ None ☐ Joint ☐ Cracks ☒ **Mortar** ☐ Roots ☒ **Wall**

Barrel infiltration (weeper).

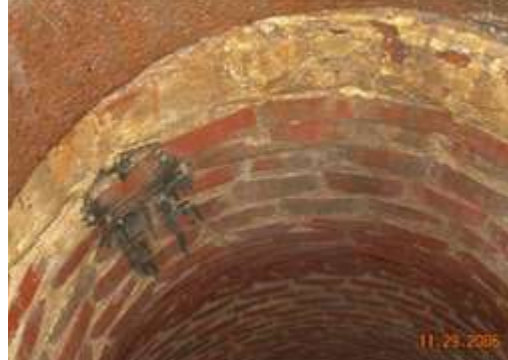
Defect

Infiltration: ☐ None ☒ **Joint** ☐ Cracks ☐ Mortar ☐ Roots ☐ Wall

Infiltration: ☐ None ☐ Joint ☐ Cracks ☒ **Mortar** ☐ Roots ☒ **Wall**

Adjustment, Corbel, and Barrel infiltration.

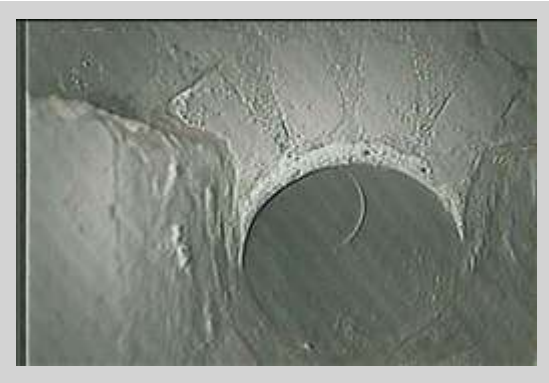
8 in. Circular Gravity Sewer Pipe Out @ 12 O'Clock

Infiltration: **Evidence** Pipe Seal Cond: **Unknown**

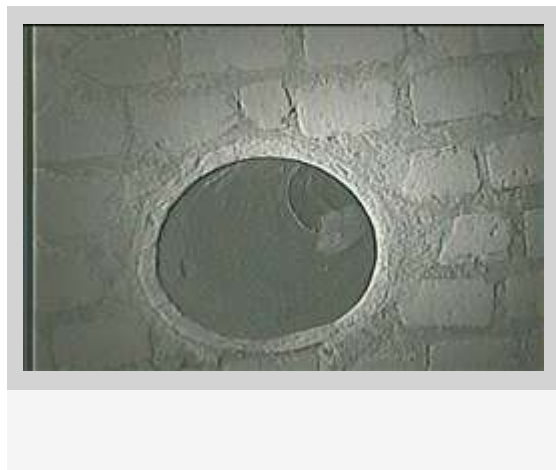
Pipe In @ 8 O'Clock

Infiltration: **Evidence**
